# Technical Appendix 9.4: Peat Landslide Hazard and Risk Assessment

## Glenouther Wind Farm EIA Report Peat Landslide Hazard and Risk Assessment

| <b>Document Title:</b> | Peat Landslide Hazard and Risk Assessment |

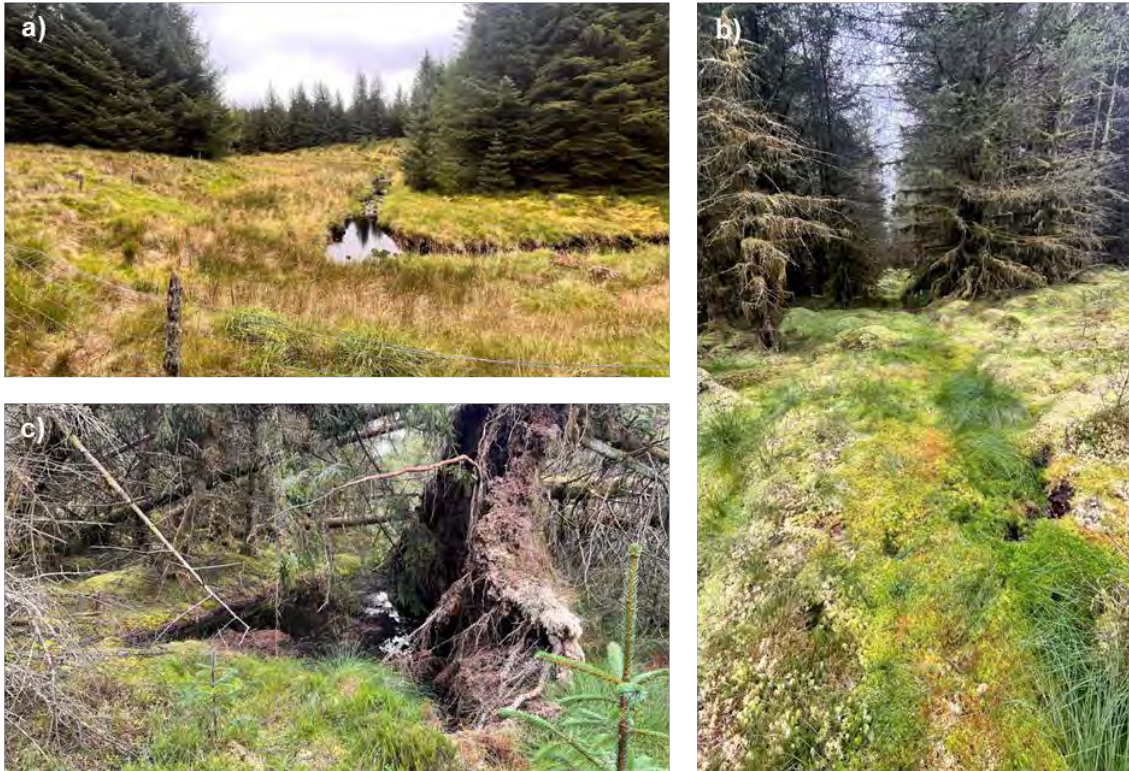
**Plate 3.2 a) Swinzie Burn in open ground, b) self-recovered forest drain with rich *sphagnum* cover, c) standing water in void left by root plate**

Swinzie Burn is the only named watercourse within the study area (**Figure 9.3.4**). Within the Site, two minor watercourses drain into Swinzie Burn, one in the centre of the Site and one in the west. 12 watercourse crossings have been identified as part of the Proposed Development, these including the aforementioned minor watercourses and artificial drains associated with forest plantation (see **Technical Appendix 9.1: Watercourse Crossings and Buffer Assessment**). Satellite imagery indicates numerous artificial drains cut into peat within the forestry and more widely in the landscape (**Figure 9.3.4**). In some locations these have self-recovered due to the very low gradients and are *sphagnum* rich.

During field survey, the ground was frequently very wet under foot, with standing water in voids left by the root plates of fallen trees. The area in the vicinity of T1 was noted to be very wet at surface in line with the marked watercourse.

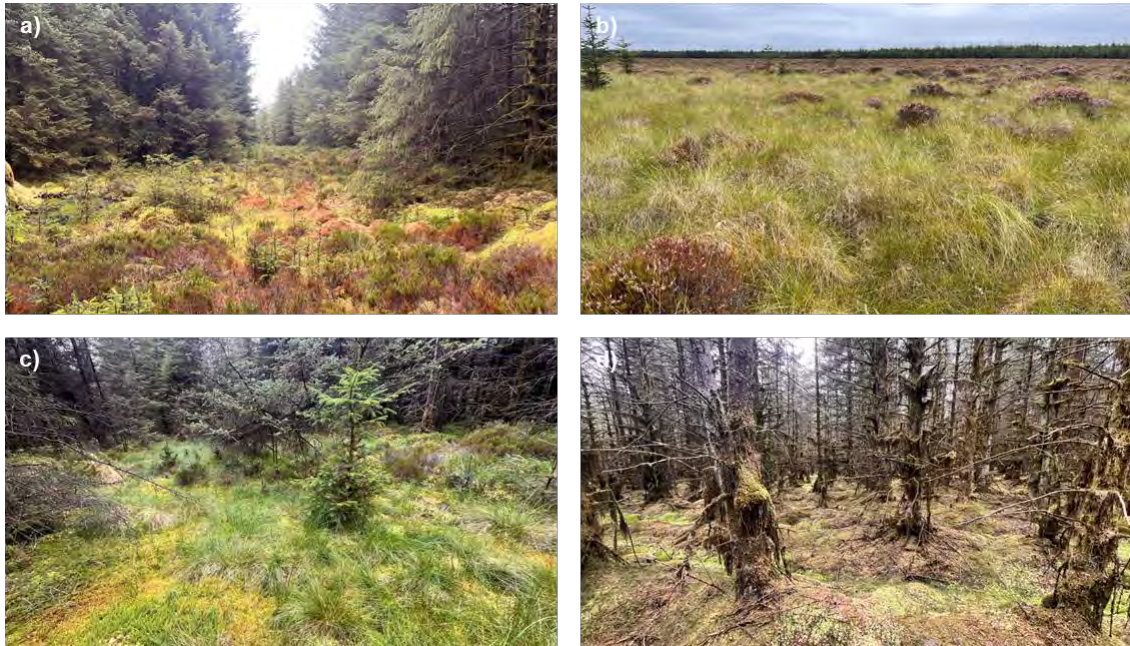
**Plate 3.3** a) Ground conditions in an open ride (including some natural regeneration of conifers from self-seeding, b) the margin of Class 1 peatland in the west of the Site, c) locally higher quality bog habitat in an open glade within forestry, d) poor habitat within forest

Plates 3.3 a to d show typical Site conditions observed during field survey.

The dominant land use type of the Site is forestry. Self-seeding of conifers is occurring into the Class 1 area of the Site and within the numerous forest rides. A small hardstanding of c. 600 m<sup>2</sup> is identified at the Site entrance, attached to the unnamed track that runs parallel to the M77.
